## Upper Columbia River Sediment Facies Mapping Stevens and Ferry Counties, Washington

Project Number: 60584878

September 2020

**AECOM**  
1111 Third Avenue, Suite 1600  
Seattle, WA 98101

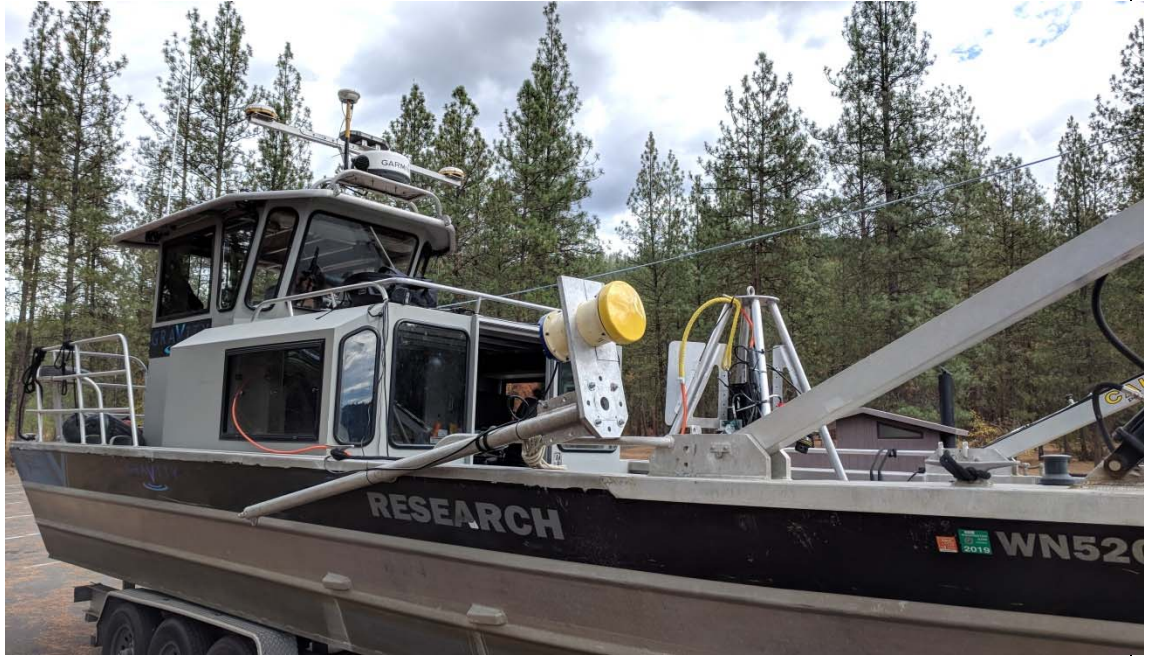
<b>Photo No.</b> 1	<b>Date:</b> 10/02/18
<b>Location:</b> Evans Campground boat launch	
<b>Description:</b> RV Tieton with ADCP and camera frame	
<b>Direction:</b> n/a

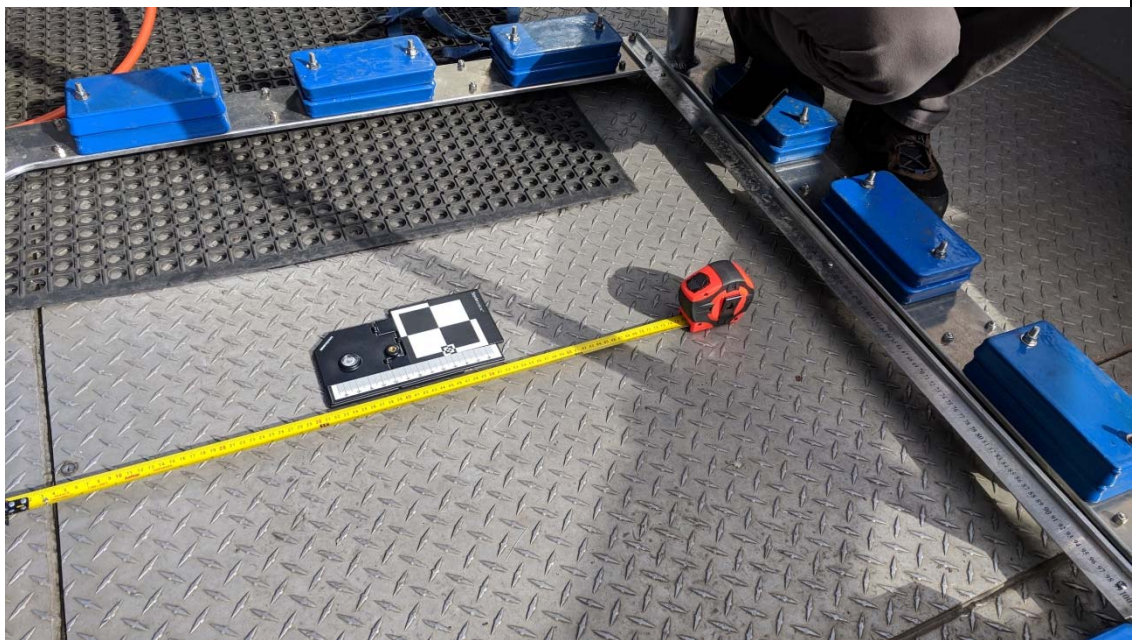
<b>Photo No.</b> 2	<b>Date:</b> 10/02/18
<b>Location:</b> n/a	
<b>Description:</b> Drop camera calibration	
<b>Direction:</b> n/a

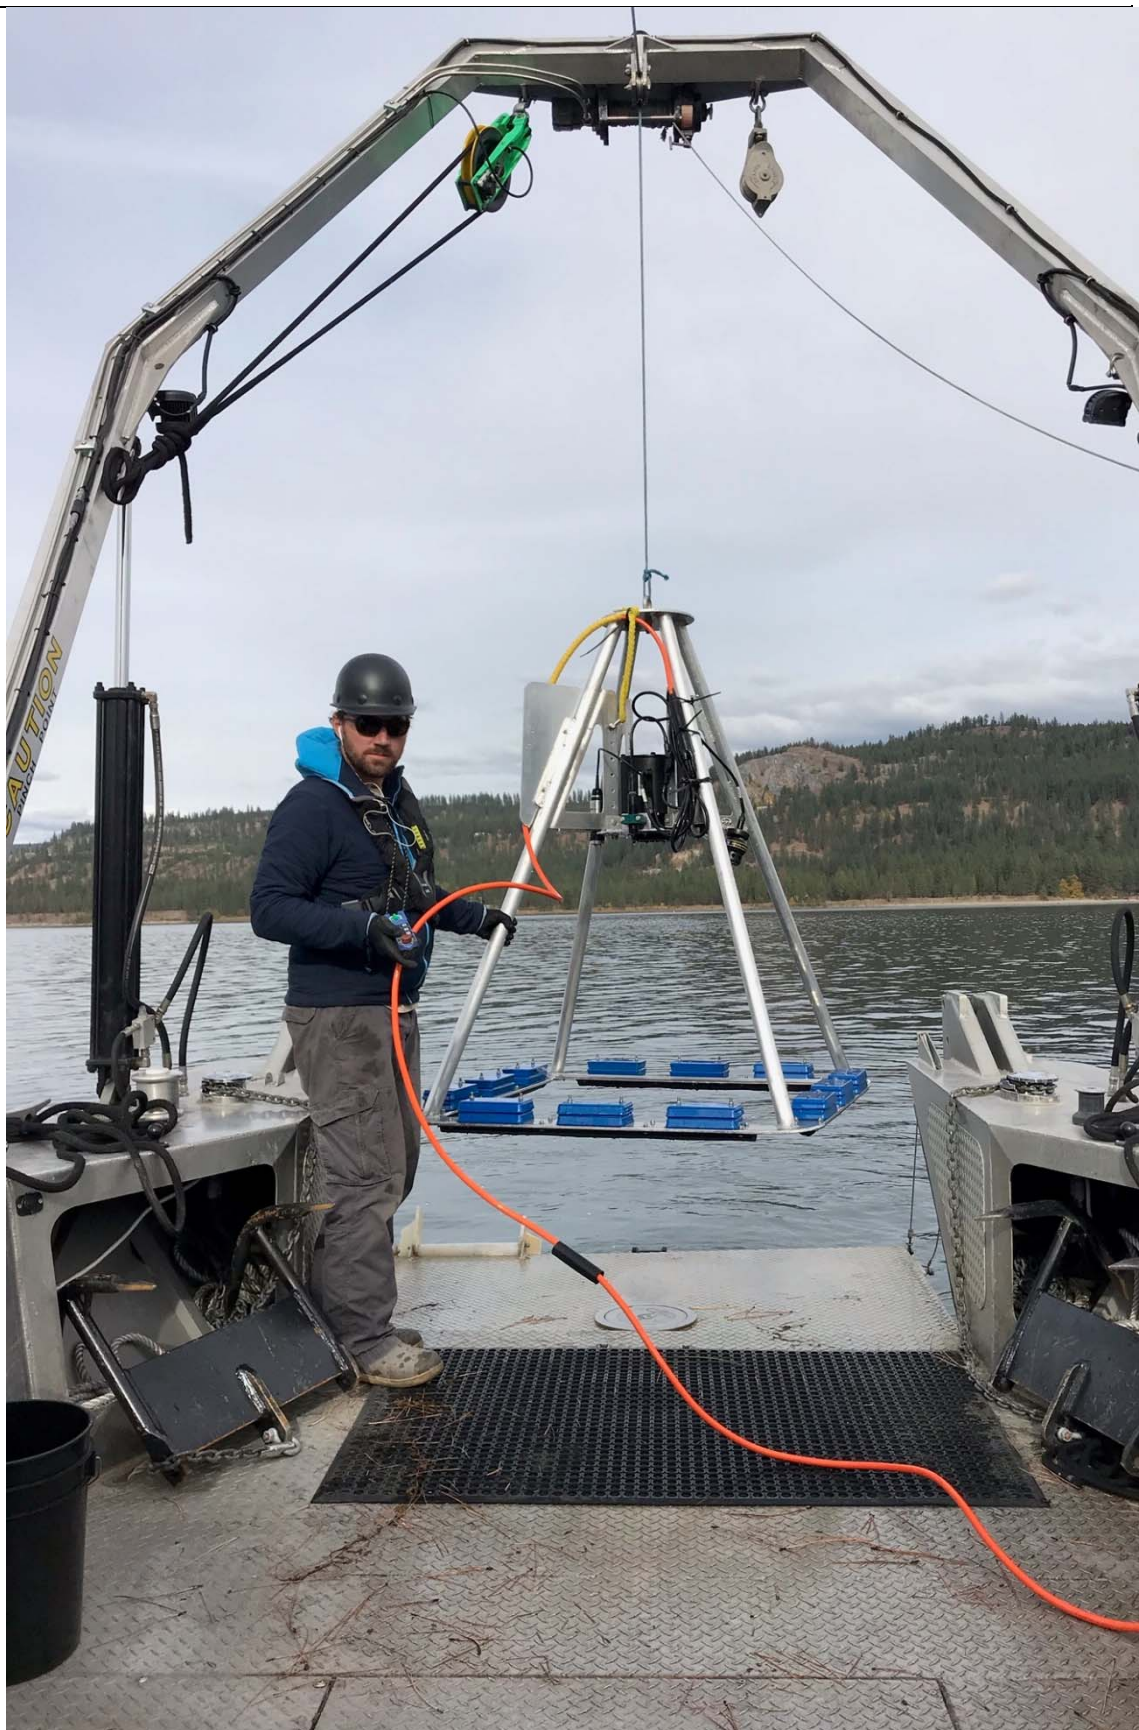
<b>Photo No.</b> 5	<b>Date:</b> 10/04/18
-----------------------	--------------------------

**Description:**  
Camera frame ready  
for deployment

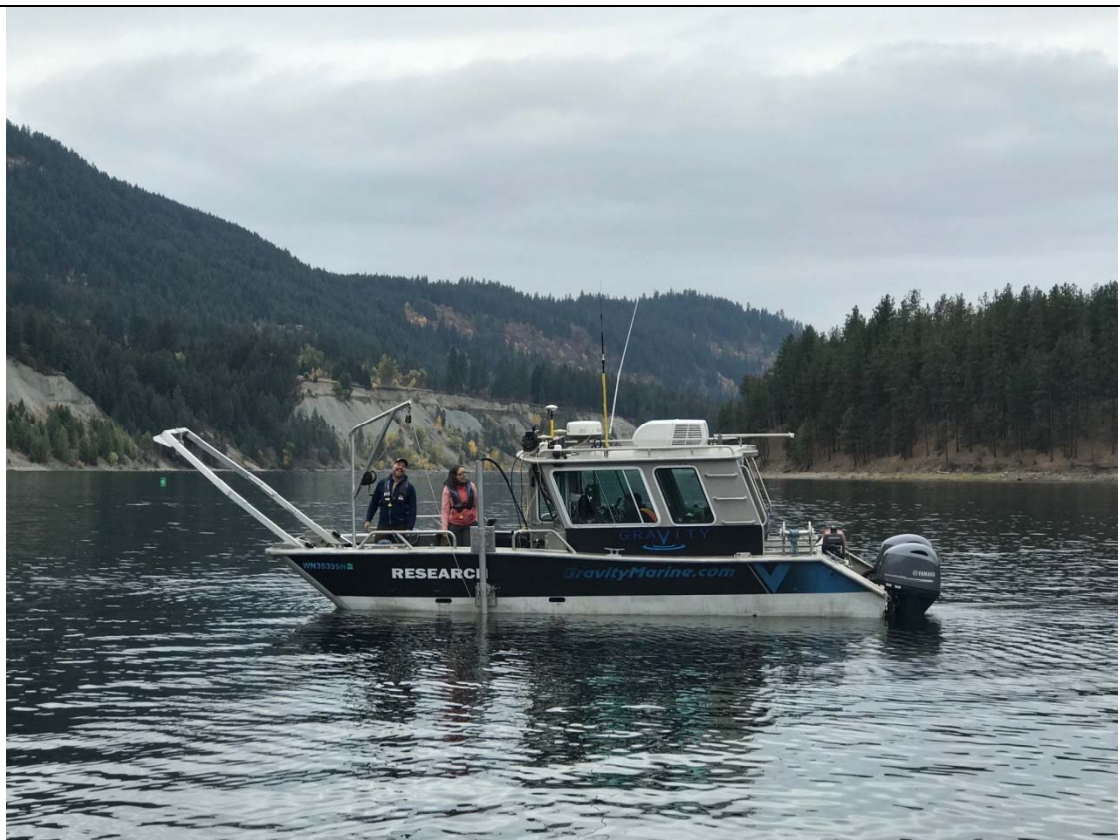
<b>Photo No.</b> 8	<b>Date:</b> 10/07/18
<b>Location:</b>	
<b>Description:</b> RV Discovery with sonar deployed	
<b>Direction:</b>

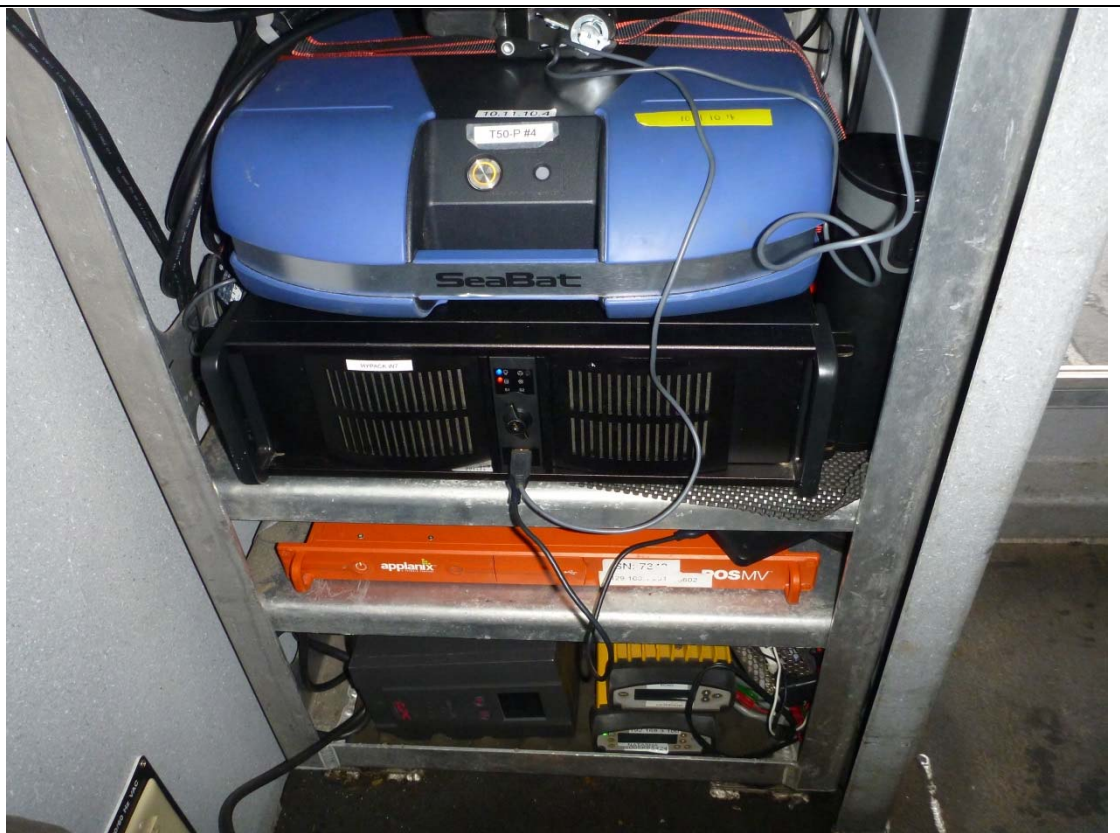
<b>Photo No.</b> 9	<b>Date:</b> 10/25/18
<b>Location:</b>	
<b>Description:</b> MBES components on RV Discovery	
<b>Direction:</b>

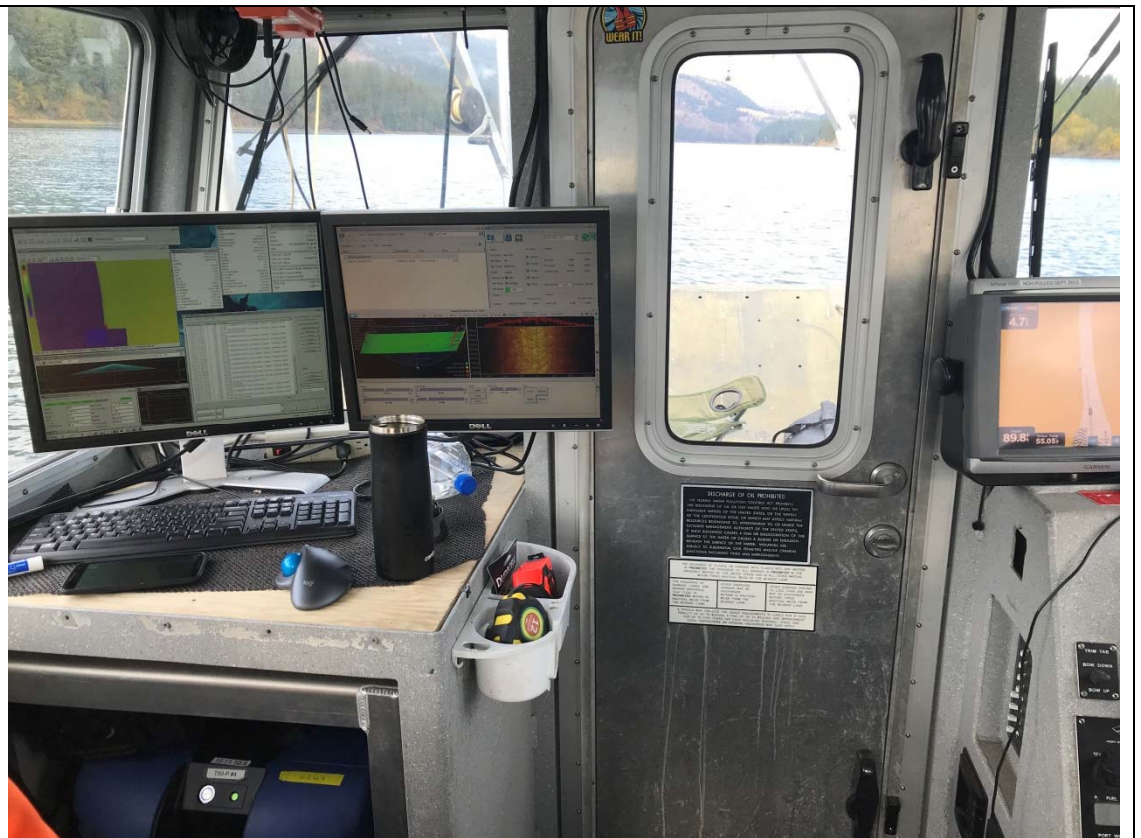
<b>Photo No.</b> 10	<b>Date:</b> 10/30/18
<b>Location:</b>	
<b>Description:</b> Hydrographer work station on RV Discovery	
<b>Direction:</b>

The acquisition station aboard the RV *Discovery* was installed and integrated by DEA prior to field deployment. The acquisition station consisted of a Windows PC with HYPACK® (including HYPACK®, HYPACK® Survey 2018, and HYSWEEP®) software, RESON SeaBat® MBES acquisition software, and DEA's proprietary LineLog software for recording acquisition settings, environmental conditions, and survey notes.

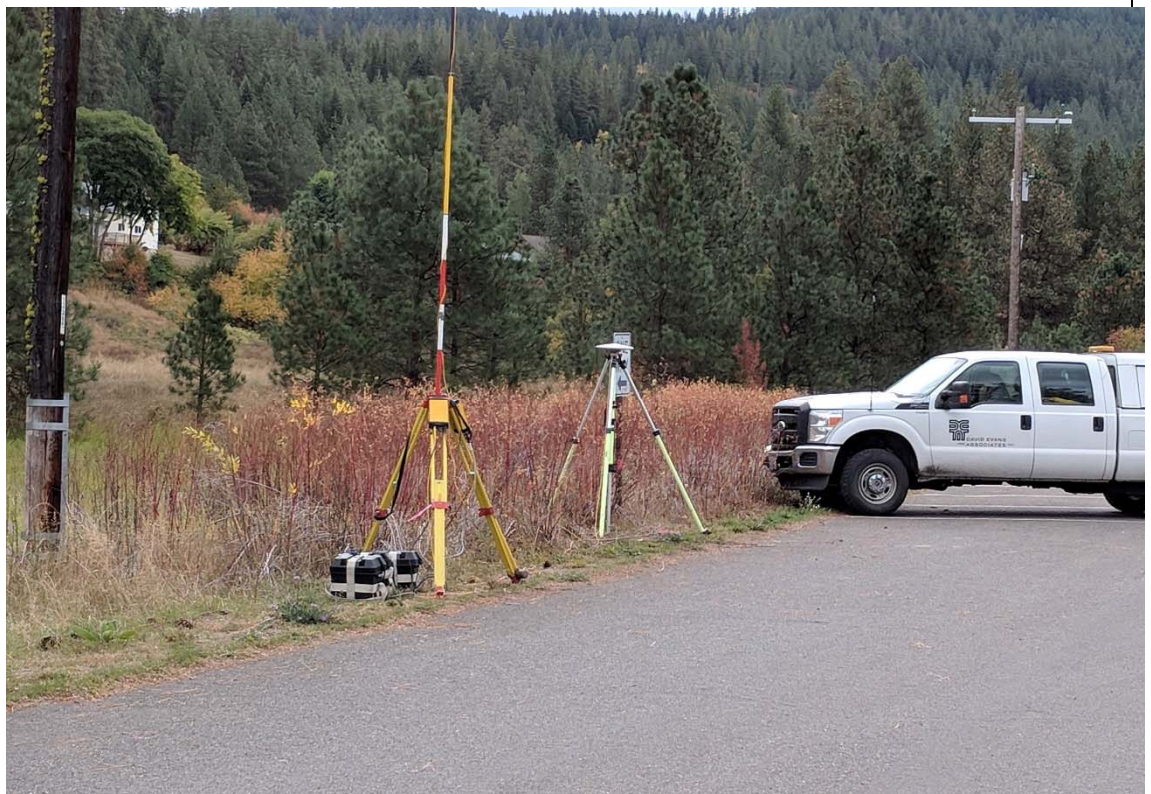
<b>Photo No.</b> 12	<b>Date:</b> 10/03/18
<b>Location:</b>	
<b>Description:</b> Base station configuration	
<b>Direction:</b>

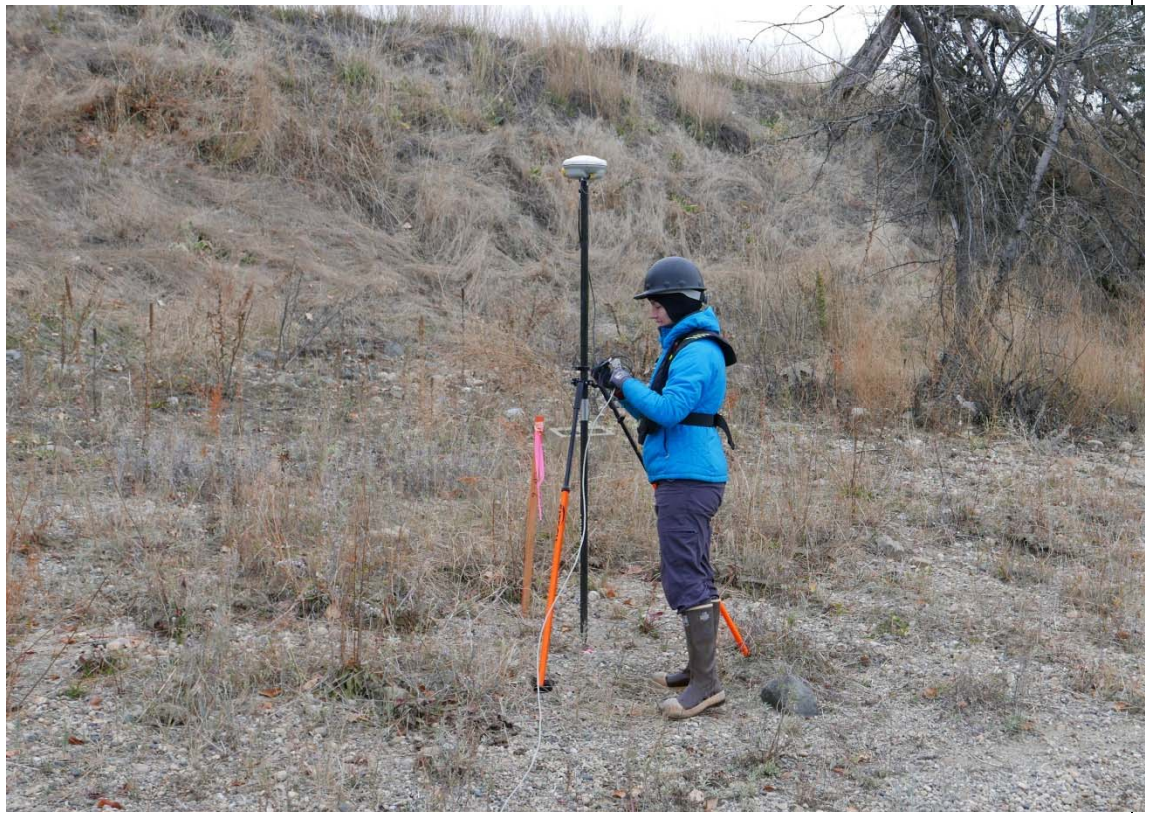
<b>Photo No.</b> 13	<b>Date:</b> 10/25/18
<b>Location:</b>	
<b>Description:</b> Registering a survey check point	
<b>Direction:</b>

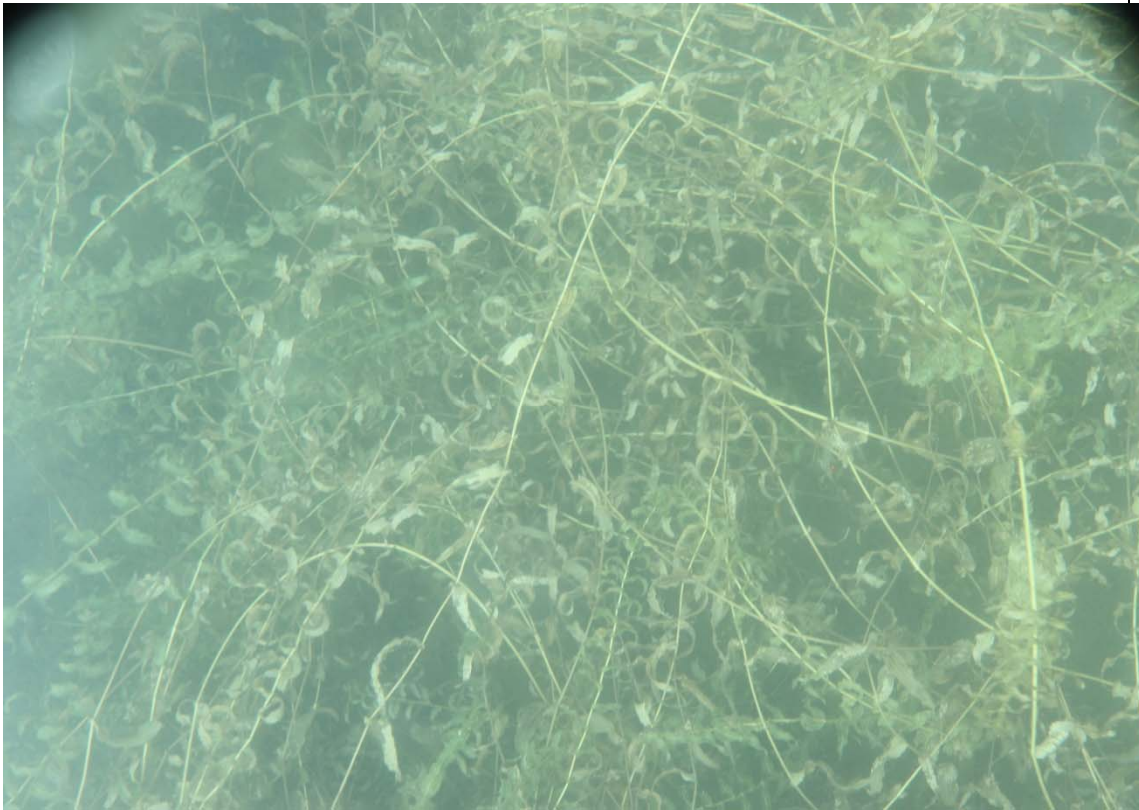
<b>Photo No.</b> 14	<b>Date:</b> 10/04/18

<b>Location:</b>		
<b>Description:</b> Drop camera image with underwater vegetation		
<b>Direction:</b>

In shallow (<4 m water depth) areas in the Upstream of Marcus Flats and China Bend AOIs, significant amounts of vegetation were observed by survey crews and visible in the MBES display. Despite the vegetation, MBES acquisition continued in these areas with the intent to remove the false, vegetation-related soundings during MBES post-processing.

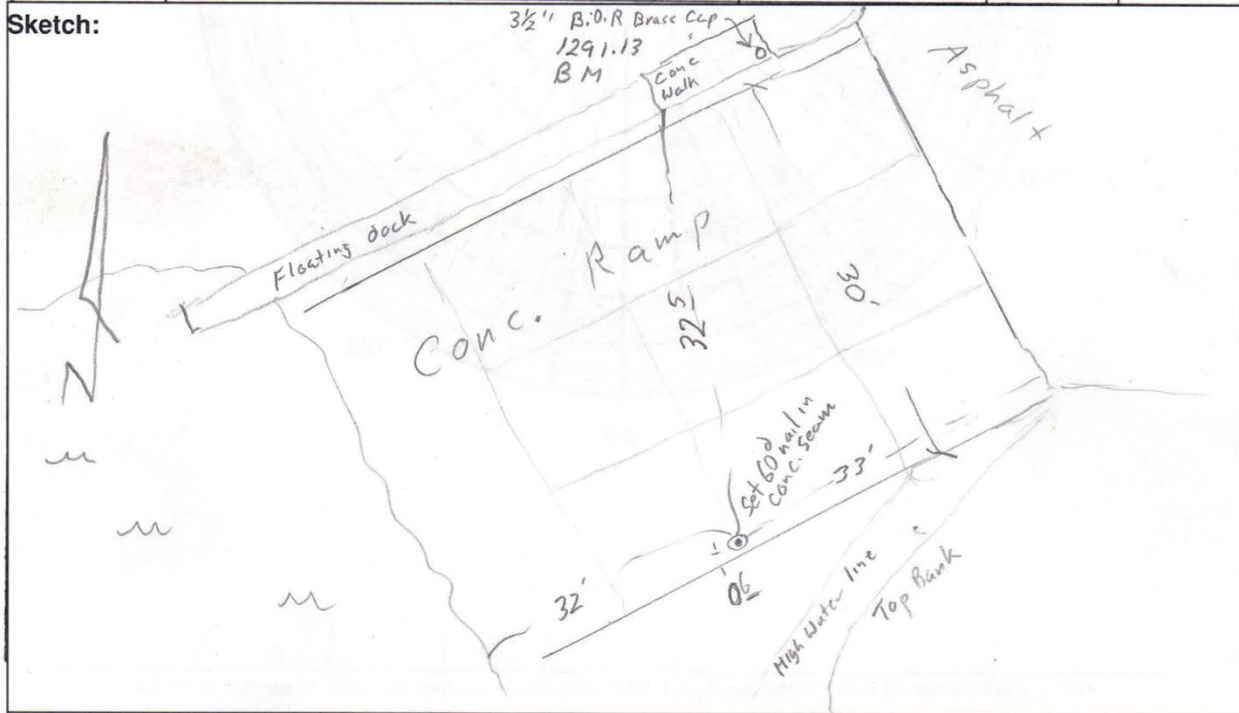
Field Sketch

SESSION NUMBER	STATION NUMBER	STATION NAME	HI (m)	HI (ft)	LATITUDE LONGITUDE	START TIME	END TIME
53512701	CP-2	CheckPoint 2	1.800	5.906	48° 41' 57.204" 118° 01' 10.661"	2:34 PM	4:42 PM
NOTES:							
NOTES:							
NOTES:

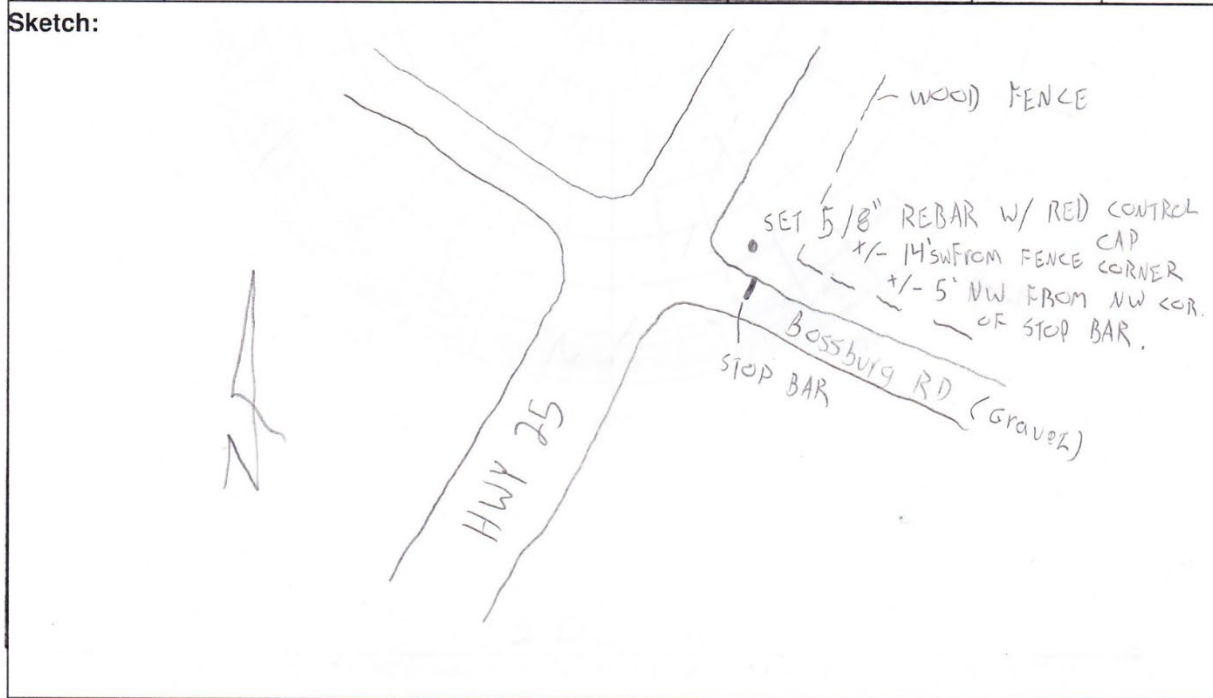
Field Sketch

SESSION NUMBER	STATION NUMBER	STATION NAME	HI (m)	HI (ft)	LATITUDE LONGITUDE	START TIME	END TIME
53512681	Bossburg	Bossburg	1.800	5.906	48°45'05.55095 118°02'40.83751	1:30	5:35
NOTES:							
NOTES:							
NOTES:

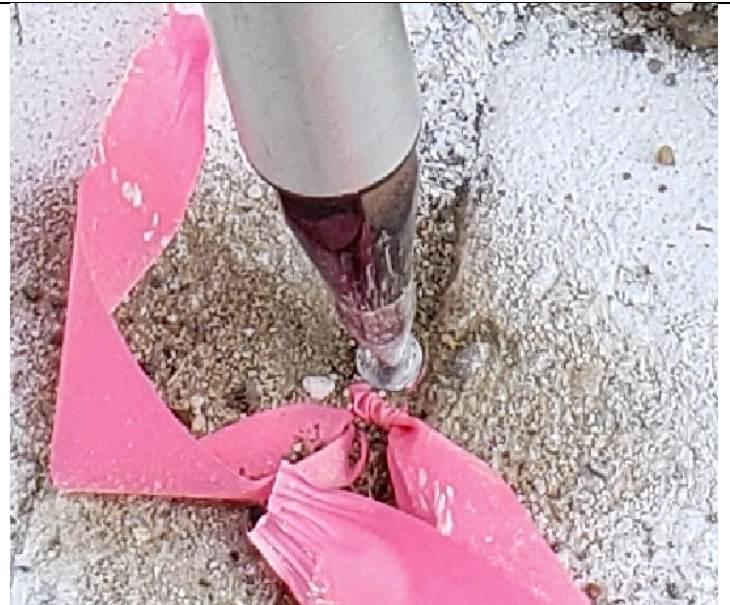
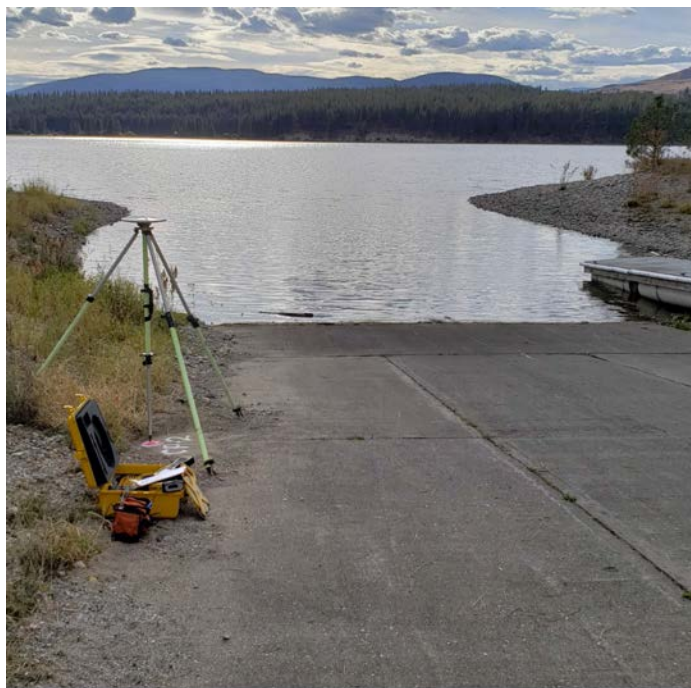
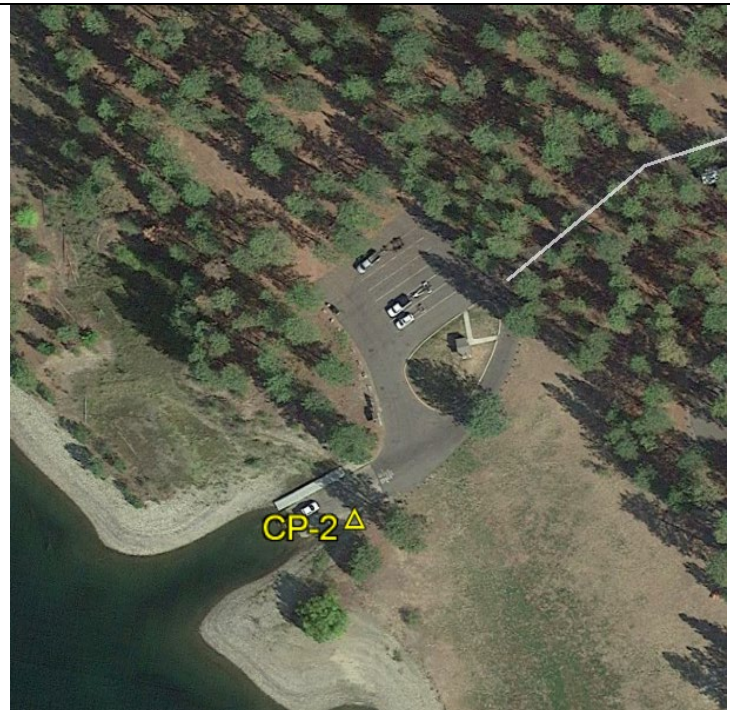
**Close-up View**

**Horizon View**

**Map**

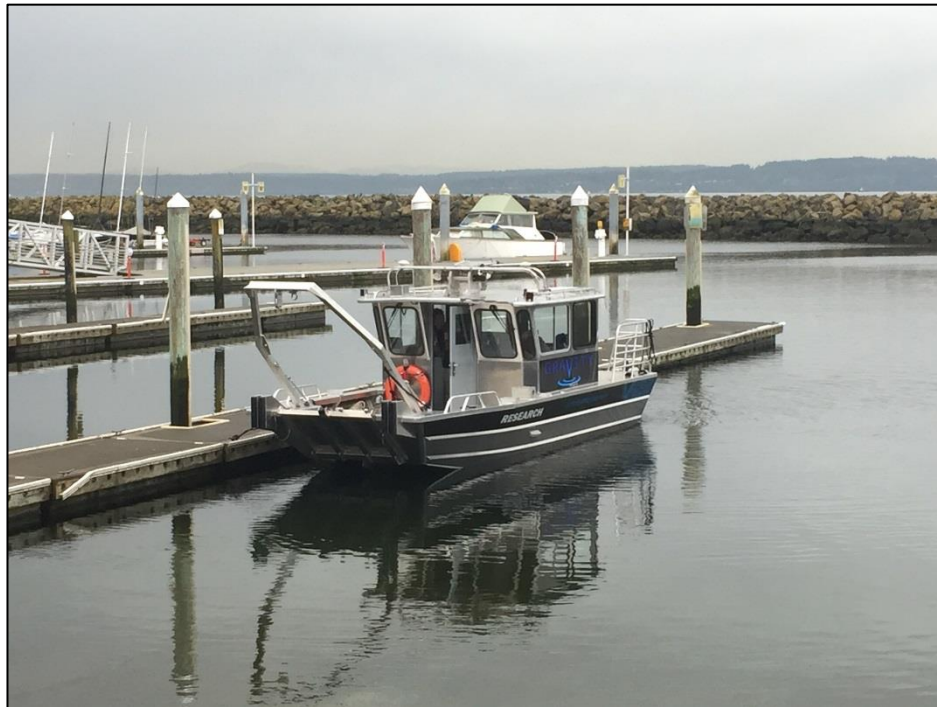
**Figure 2.** R/V *Discovery*, owned and operated by project partner Gravity Marine LLC.

The vessel for this survey will be the R/V *Discovery*, owned and operated by project partner Gravity Marine, LLC (Gravity). The *Discovery* will be outfitted with a Teledyne-Reson SeaBat T50-P precision multibeam sonar. The T50-P logs 512 soundings with each sonar ping over a nominal swath angle of 140 degrees (70 degrees to each side of the sonar). The effective swath width will be determined through cross line analysis to determine the maximum swath angle that meets survey requirements. To maximize swath coverage and extend coverage up along the shoreline, the sonar head may be tilted 15 degrees outboard.
